# Water & Wastewater NEWS

## Case Study: Seawall System Used to Retain Earthen Walls

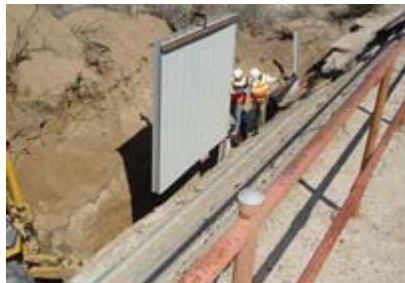
Ten-foot assembled sections of Truline, a cast-in-place modular wall system, are being set in place to prevent soil erosion.

According to reports from the Pima County, the solution minimized the need for heavy equipment and a large crew. The 5-person crew dug a trench and then drove 10-foot sheets rigged for installation in 10-inch-wide sections. The product's u-channel shape allowed the crew to pour concrete directly into place. The job, which began Feb. 27, 2008, took about three weeks from start to completion, according to Chris Albright of KE&G Construction.
